***DRAFT***  
**FOCUSED REMEDIAL INVESTIGATION REPORT**  
**FOR**  
**RICHARDSON FLAT TAILINGS SITE**

**SITE ID: UT980952840**

**December 17, 2002**

**Resource & Environmental Management Consultants d.b.a. RMC  
8138 South State Street, Suite 2A  
Midvale, Utah 84047**

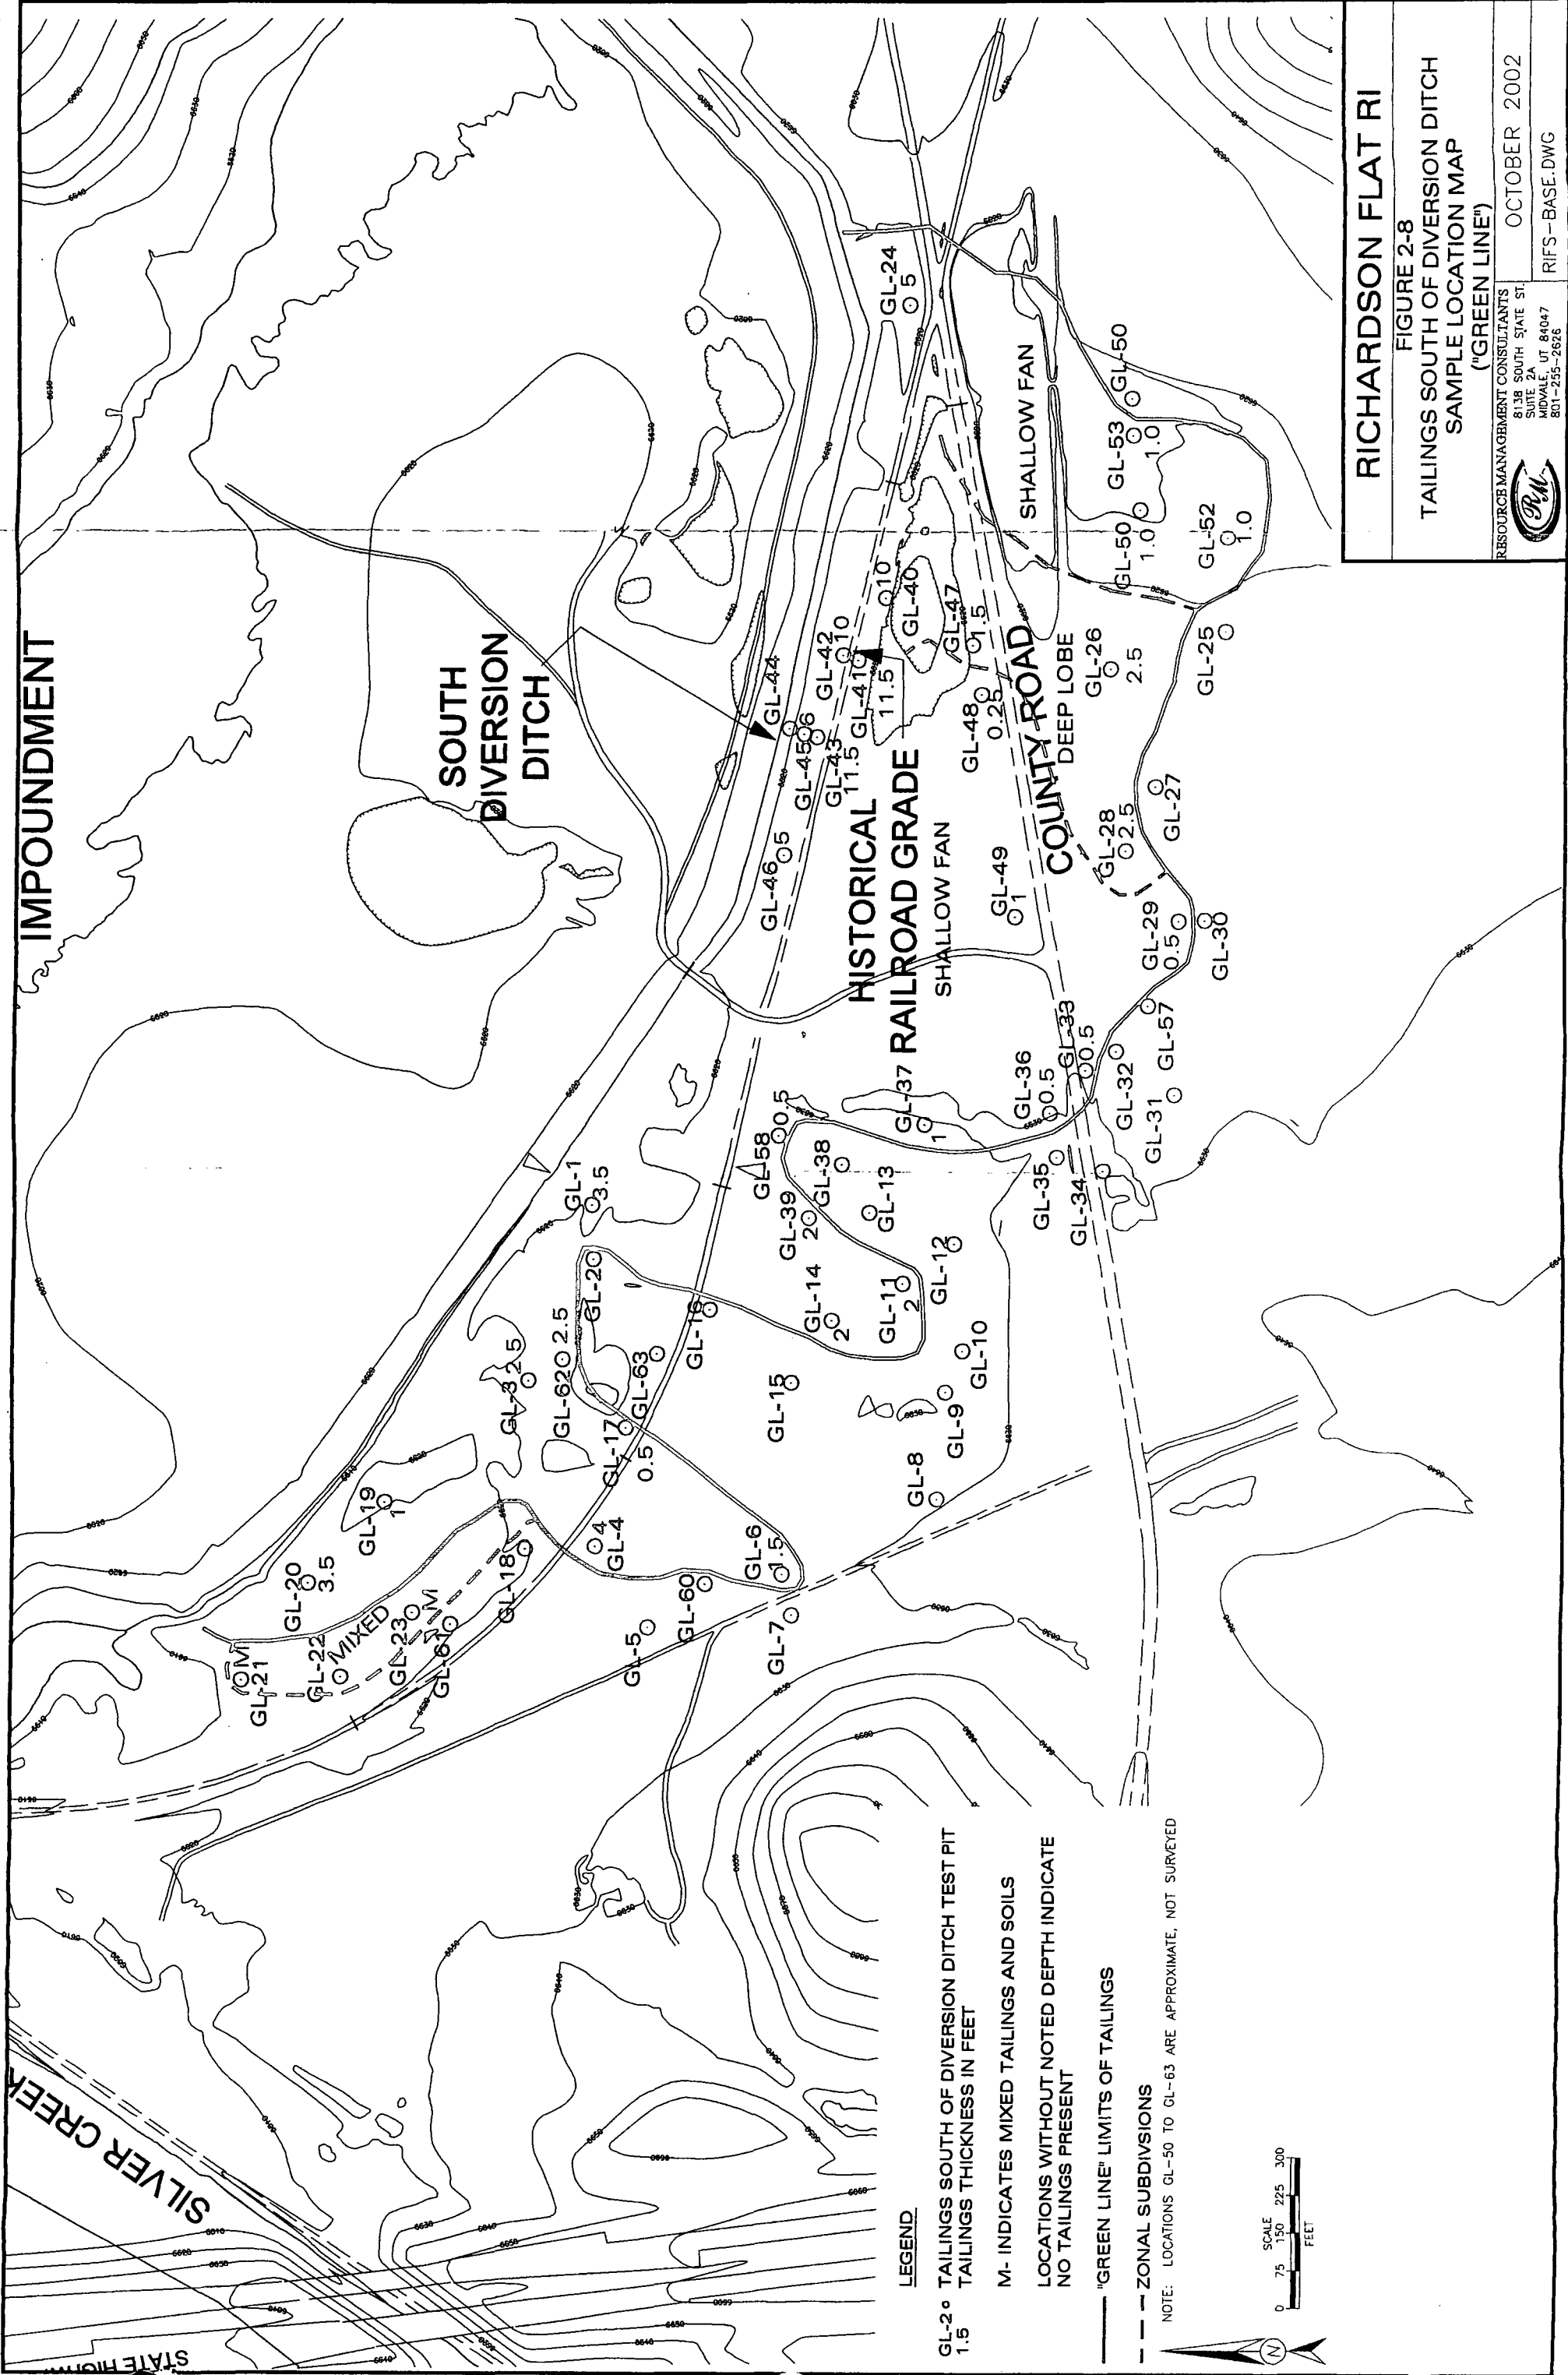
FIGURE 2-8  
TAILINGS SOUTH OF DIVERSION DITCH  
SAMPLE LOCATION MAP  
("GREEN LINE")

The physical characteristics of the tailings south of the diversion ditch are identical to the tailings observed within the impoundment area (Section 3.1.8). The observed thickness of the tailings ranged from 6 inches to 11.5 feet. The thickest area of tailings (GL-41 and GL-43) were observed in an area located adjacent to the old rail grade in the southeastern portion of the study area.

Tailings were observed in thirty-six (36) of the sixty-three (63) test pits excavated. The extent and thickness of the tailings are presented in Figure 2-8. Two of the test pits that contained tailings (GL-21 and GL-23) contained a mixture of tailings and soil. This area appears to have been disturbed. In twelve (12) of the locations that contained tailings, the tailings were not covered (Figure 3-1). The remaining twenty-four (24) locations contained a soil cover over the tailings (Figure 3-1). The soil cover varied from a brown, silty loamy topsoil to fill material. The interface between the tailings and the overlying soils is generally sharp and distinct.

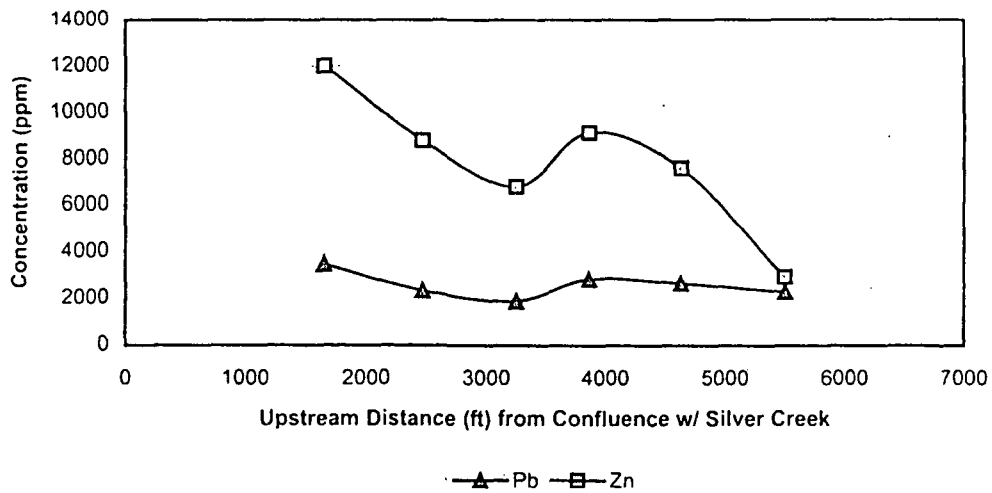
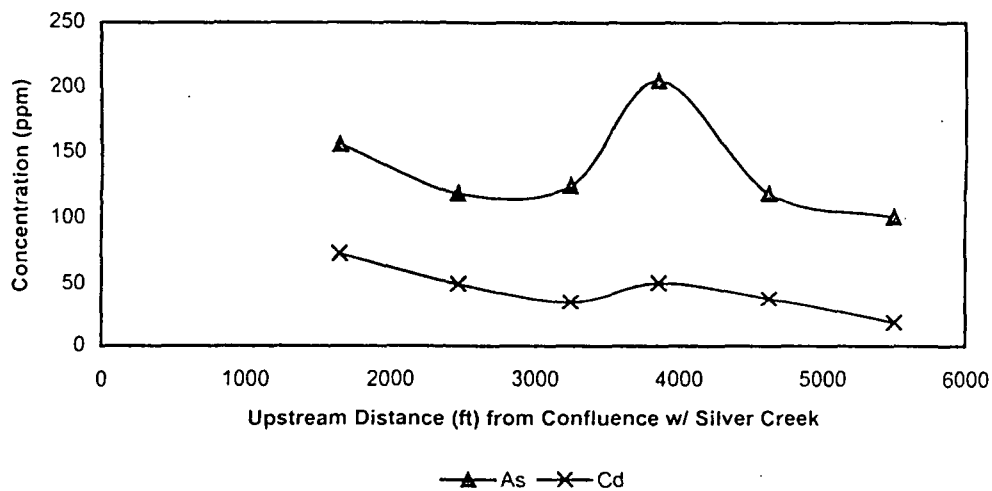
FIGURE 5-6  
METALS CONCENTRATIONS IN SOUTH  
DIVERSION DITCH SEDIMENTS

The highest lead concentration was observed at the SD-1 location, this sample also contained the highest silver, cadmium, copper, iron, mercury and zinc concentrations. Location SD-1 is located in the lower most portion of the diversion ditch (See Figure 2.7). Arsenic, lead and zinc concentrations are lowest in the sample collected at the most upstream location (SD-6) of the ditch. The concentrations of these three metals is roughly proportional in the six samples collected. The distribution of metals in sediments along the diversion ditch is further discussed in Section 5.0.

A comparison of the mineralogy of tailings and sediment samples (Table 5-6) indicates that the bulk of the materials are composed of similar percentages of quartz, calcite, dolomite, pyrite, and clinocllore (a mica) suggesting a common source. However, the sediment sample lacks galena (PbS) which was found in all tailings samples, but contains sphalerite (ZnS) in all samples except the uppermost station SD-6. The sediment sample also lacked the hydroxides (tosudite, brushite, carlosturanite) and iron oxide reported in some of the tailings samples, but contained a wide assortment of other minerals including feldspars (albite, anorthite, sanidine, orthoclase), micas (paragonite, muscovite), clays (nontronite, montmorillonite), and an amphibole (ferro-gedrite). The sediments thus appear to be a mixture of biologically derived sulfide precipitates, tailings and imported soils. This combination of materials is due to past uses and reconstruction activities. In 1992 and 1993, United Park reconstructed the south diversion ditch by decreasing the slope of its banks from nearly vertical to a more gradual slope. United Park also placed a clay soil cover over the re-sloped banks of the south diversion ditch, down to and including areas of the banks underwater. The new banks were then seeded with appropriate varieties; presently, the existing ditch banks are vegetated. United Park did not disturb the bottom of the ditch bed.

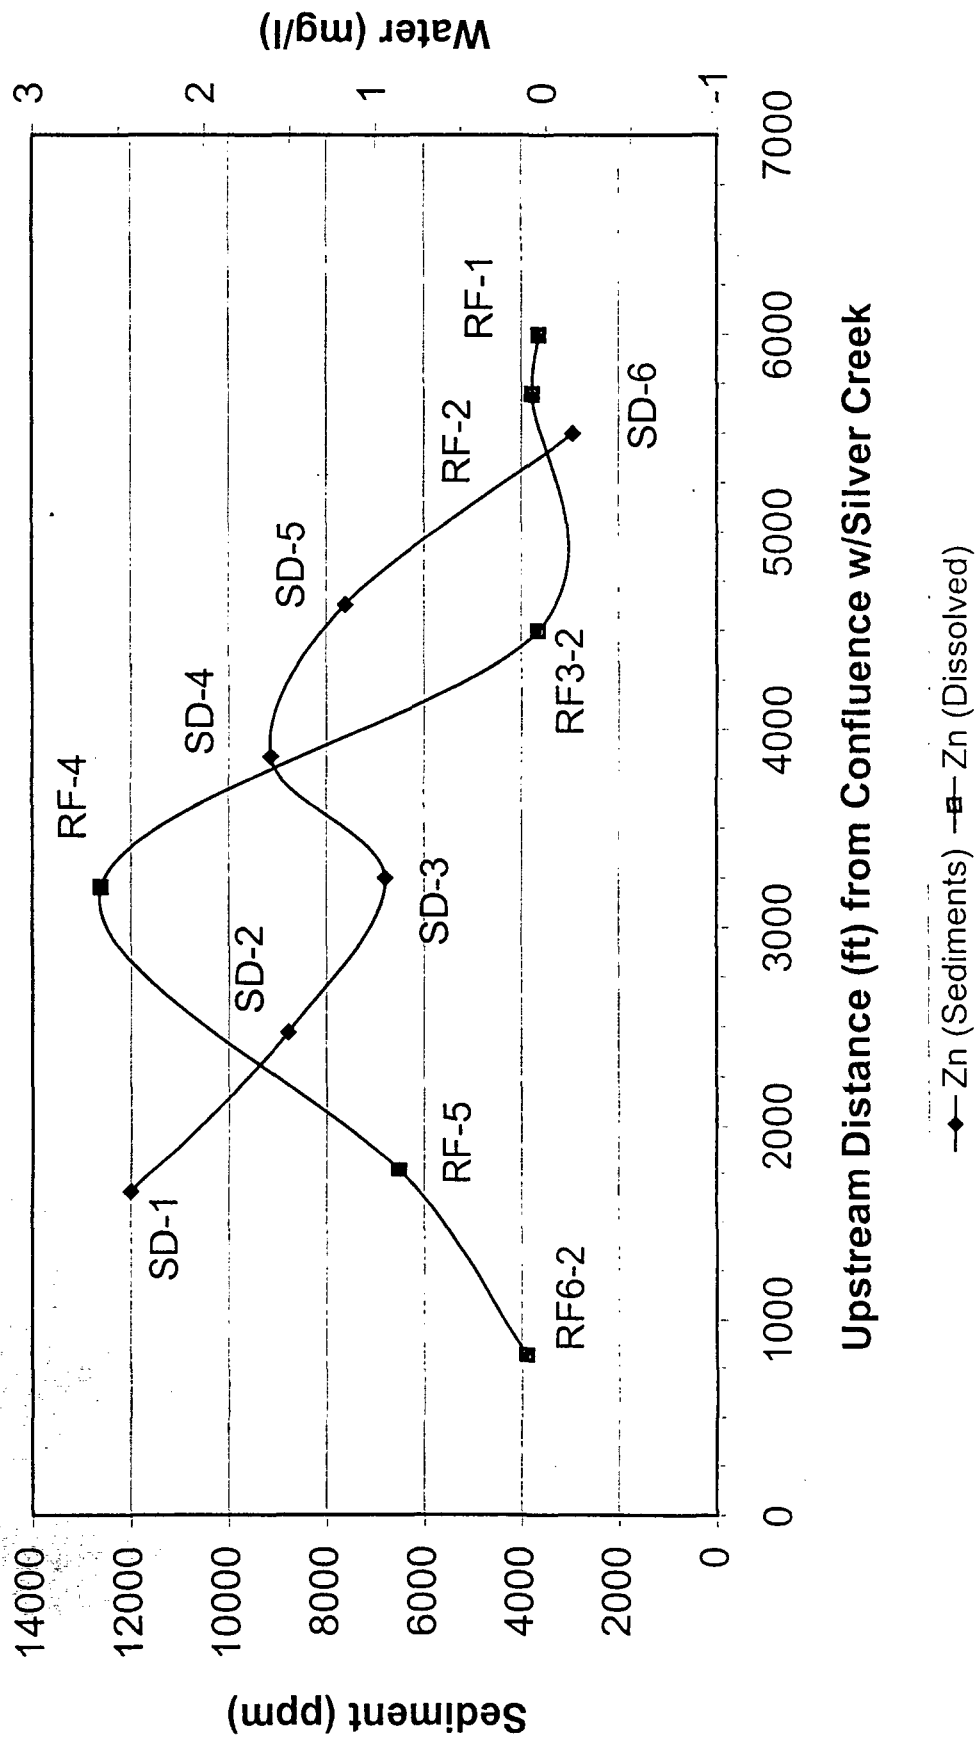
**Figure 5-8**  
**Zinc Concentrations in Sediment (5/11/01) and Water**  
**(5/7/01) along South Diversion Ditch**

Considering the behavior of metals in water and sediments within the diversion ditch as a coupled system, a better understanding of the processes that are occurring emerges. For example, plotting the water results from 5/7/01 and the sediment results from 5/11/01 (Figure 5-8) together shows a generally inverse relationship between zinc concentrations in the water and solid phases. A similar relationship is observed for lead (Figure 5-9). Figure 5-10 provides plots of dissolved zinc versus other chemical parameters such as sulfate, TDS, bicarbonate, calcium, and manganese showing clear relationships between zinc and other chemical species. Between RF-2 and RF-4 major changes in water and sediment chemistry are occurring that strongly indicate a major inflow of poor quality, oxygenated water. In this reach, the concentrations of the following parameters increase sharply by the listed factors: TDS 2X, sulfate 10X, zinc 65X, manganese 92X, magnesium 3X, bicarbonate 2.5X, calcium 4X. RF3-2 is a tributary to this reach of the ditch the low concentrations are a "clean" water source draining into the ditch and is not experiencing similar concentration levels as RF-12. Field measurements of temperature and pH (Figure 5-11) also indicate that substantial mixing is occurring in this reach. The inflow into the ditch in this area is likely from cooler, lower pH, water, possibly from the ponded area south of the County Road.

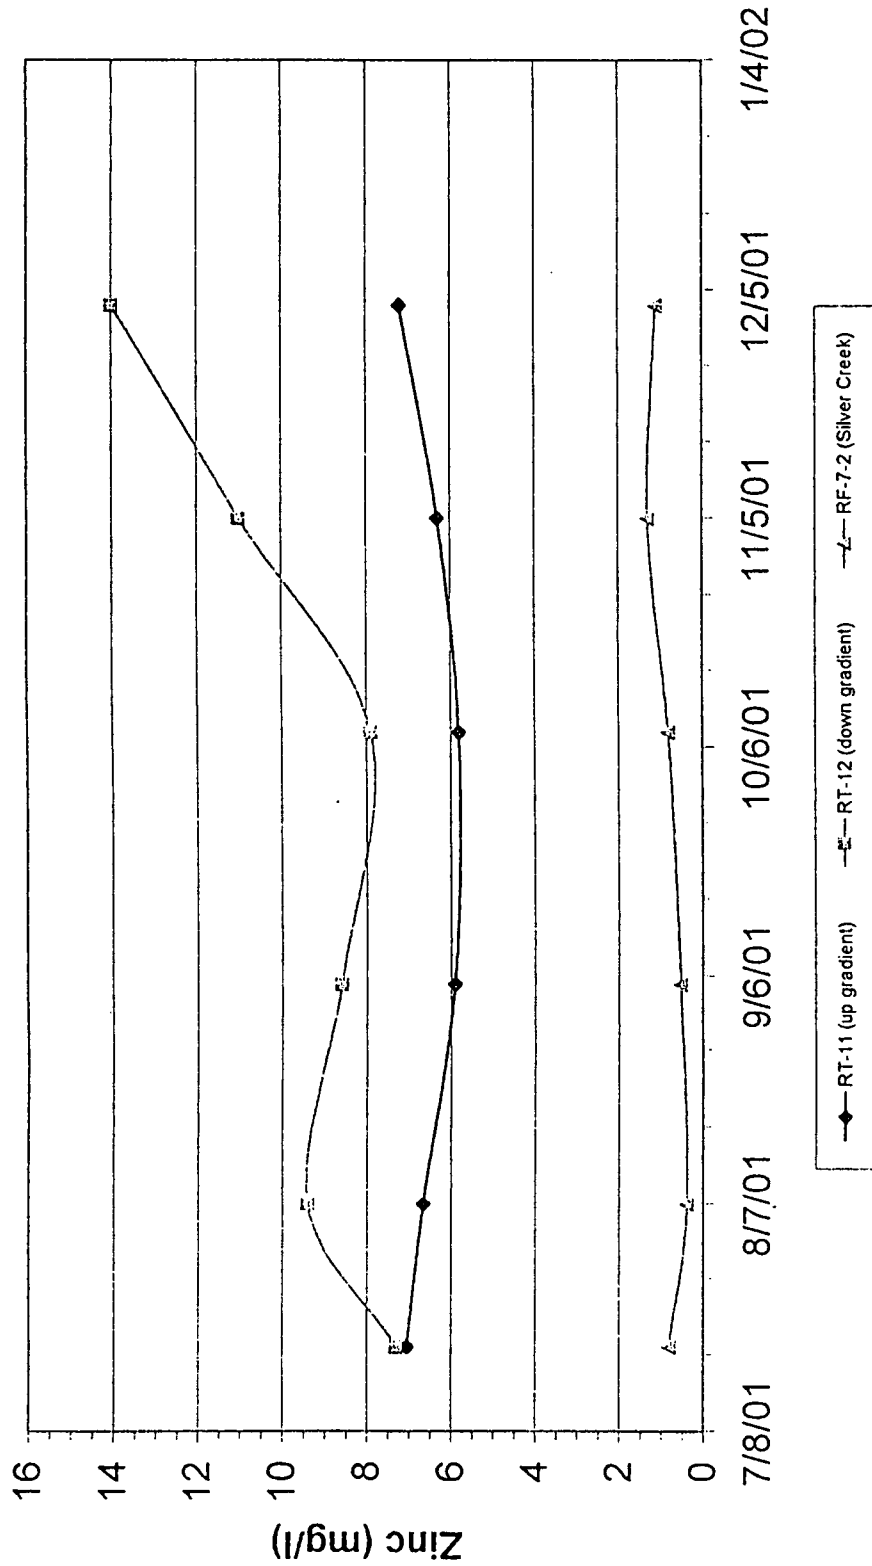
FIGURE 5-14  
TIMES SERIES PLOT OF DISSOLVED ZINC  
CONCENTRATIONS IN SILVER CREEK  
ALLUVIUM

Elevated concentrations of total and dissolved zinc are observed in groundwater within the Silver Creek alluvium. As shown in Figure 5-14, dissolved zinc concentrations range from 5.6 to 10 ppm in upgradient monitoring well RT-11 and from 6.4 to 22 ppm in downgradient monitoring well RT-12. As is apparent from the histogram of dissolved zinc concentrations, (Figure 5-15). The down-gradient zinc concentrations correspond to some of the highest zinc concentrations observed in surface and groundwater samples collected for the focused RI for the Site. Dissolved zinc concentrations of up to 85 mg/l were measured in Floodplain Tailings wells adjacent to Silver Creek. Other ranges of dissolved zinc concentrations in site waters include:

The elevated zinc concentrations in groundwater adjacent to Silver Creek may be the result of several factors including: (1) dissolution of zinc from tailings and mine waste within the alluvium, Floodplain Tailings or within the Silver Creek embankments, (2) oxidizing conditions created by surface/groundwater exchange, and (3) ideal geochemical conditions for the dissolution of zinc-containing minerals (i.e., readily soluble minerals, available major anions for complexation, lack of available surface adsorption sites).

The increasing concentrations of zinc, in conjunction with generally decreasing TDS levels, between RT-11 and RT-12 should be noted. Although the concentrations in these two monitoring wells are not substantially different from a statistical standpoint, the increase may be caused by spatial heterogeneities in hydraulic conductivity (a function of grain size), adsorption potential, and sedimentation patterns. Hydraulic conductivity and groundwater flow rates are likely much higher near RT-11, where Silver Creek is flowing at a much higher rate than near RT-12 where it is partially dammed by the highway and beaver dams. Slower groundwater flow rates would allow for a longer residence time and increase the potential for zinc dissolution, however this is not consistent with the decrease in TDS. Variations in adsorption coefficients may be due to mineralogy (relative percentage of sulfides, feldspars, calcite), grain
